Boots & Coots tames Iraq's oil well fires during war

William Markus, Boots & Coots Safety Engineer

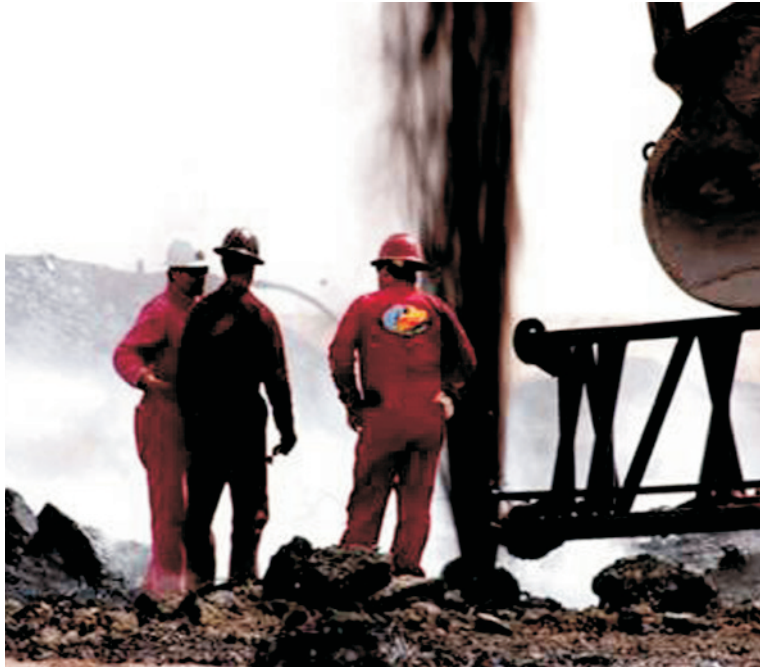
Boots & Coots personnel supervise the insertion of a stinger that would be attached to a Halliburton pump that delivered drilling mud, controlling the well pressure and killing the well.

The firefight was quick and successful, only requiring a portion of the stored water. B&C personnel then inserted the stinger using the B&C Athey wagon. Attached to the stinger is high pressure pipe that connected to a Halliburton pump truck, delivering drilling mud.

The truck pumped a necessary amount

of drilling mud to control the well pressure through the pipe, killing the well.

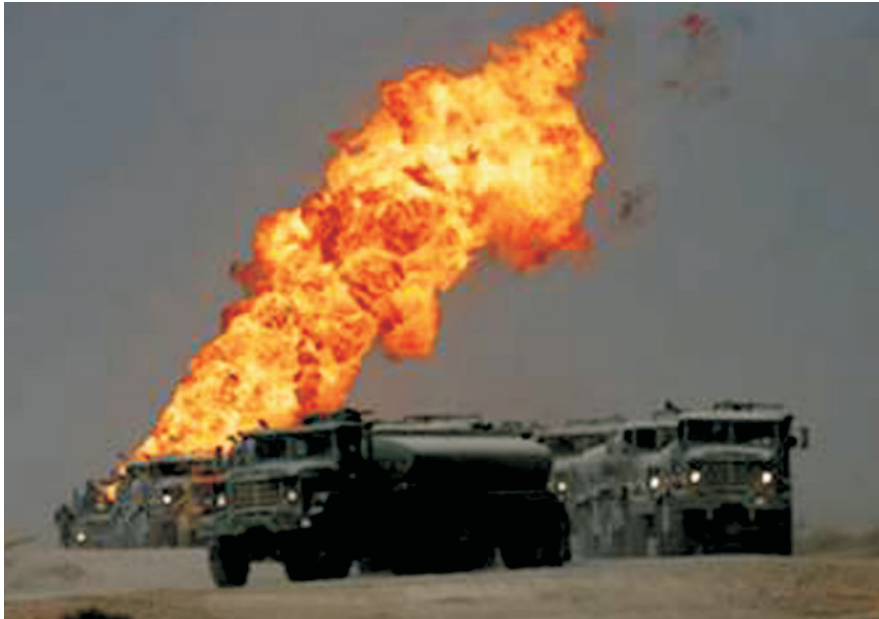
One of the Iraq wells was in very close proximity to a road used by military convoys. In preparation for extinguishing the fire, oil collection pits and drainage ditches were constructed at Boots & Coots' direction.

B&C built a road through the desert around well #64 to keep coalition forces and patrol from being soaked by oil.

B&C also built dykes around the well area and down hill to stop oil from flowing onto the road, further hampering travel and constant coalition traffic.

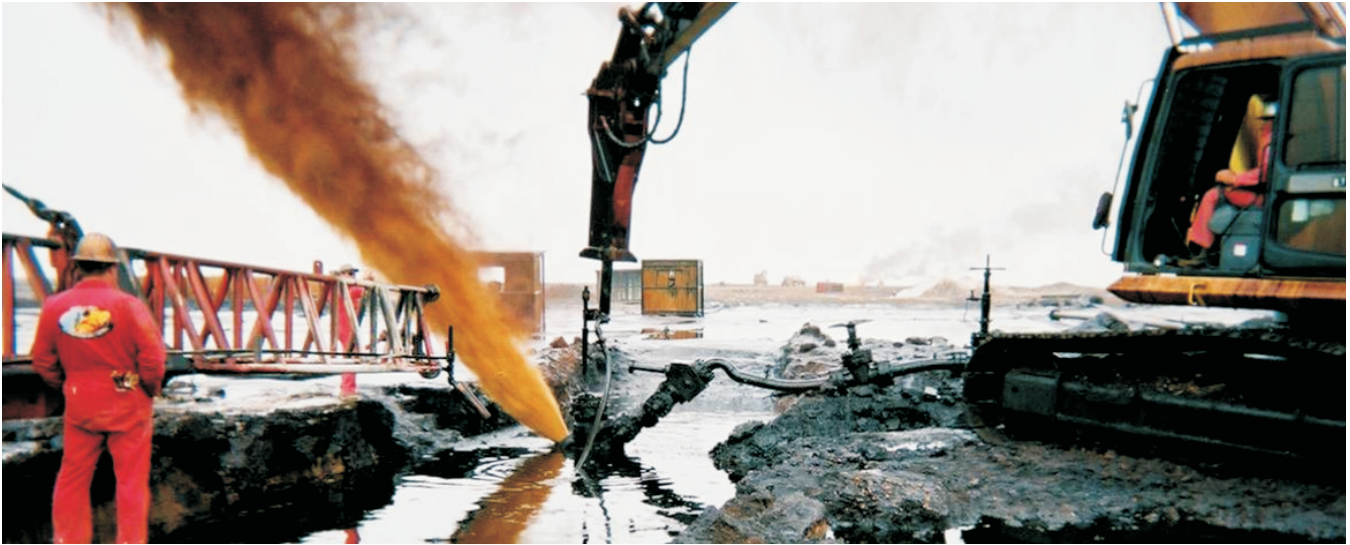
The second well that B&C tackled posed a different challenge, more hazardous than the first. The fire from well #64 burned at a 45° angle.

The B&C team leader determined the casing valve had been damaged but the production tree was still intact.

Oil and gas flow from Well #64 that was exiting at a 45° angle. This presented a problem, as the fire extended toward the main supply route for coalition forces. When the fire was extinguished, Boots & Coots used two stingers in the casing valve and tubing to pump mud and kill the well.

Halliburton's abrasive jet cutter successfully removed the damaged valve, and the stinger was prepared to kill the well. But the procedure would not operate without a hitch.

When B&C pumped 9# mud down the 7 1/16-in. casing valve, pressure reoccurred via the 2" production tubing.

The circumstances required a bullhead operation from both the casing valve and tubing head.

By using two stingers, one in the casing valve and one in the tubing, both pumping mud under pressure, the bullhead technique proved successful on the well flow. After several minutes of pumping, the well died.
